# NATIONAL TRANSPORTATION SAFETY BOARD

## RAILROAD ACCIDENT REPORT

DERAILMENT OF  
SOUTHERN PACIFIC TRANSPORTATION COMPANY  
FREIGHT TRAIN ON MAY 12, 1989  
AND SUBSEQUENT RUPTURE OF  
CALNEV PETROLEUM PIPELINE ON MAY 25, 1989  
SAN BERNARDINO, CALIFORNIA

| <b>1. Report No.</b><br>NTSB/RAR-90/02 | <b>2. Government Accession No.</b><br>PB90-916302 | <b>3. Recipient's Catalog No.</b> | |

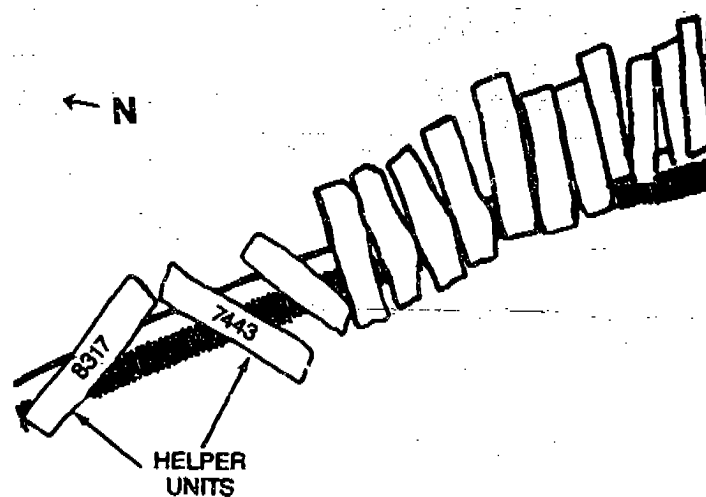
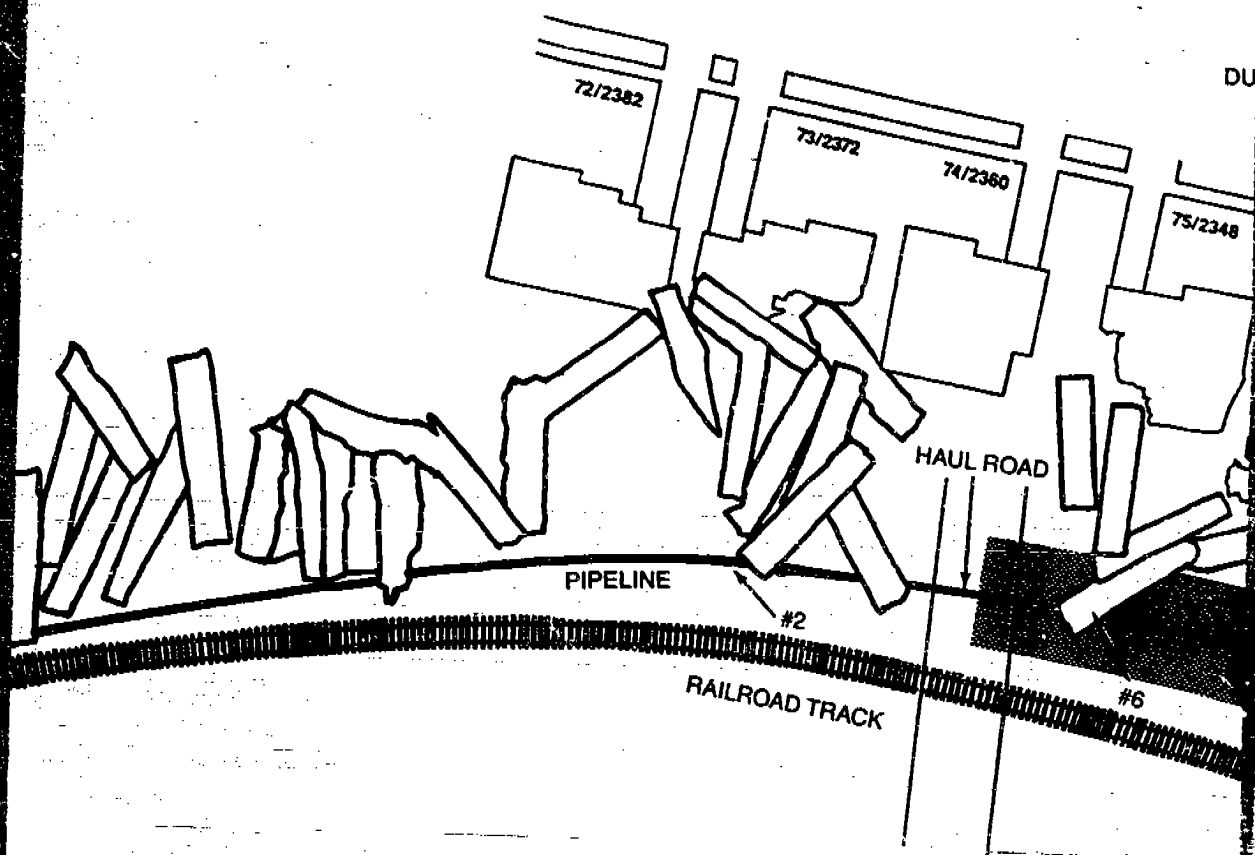
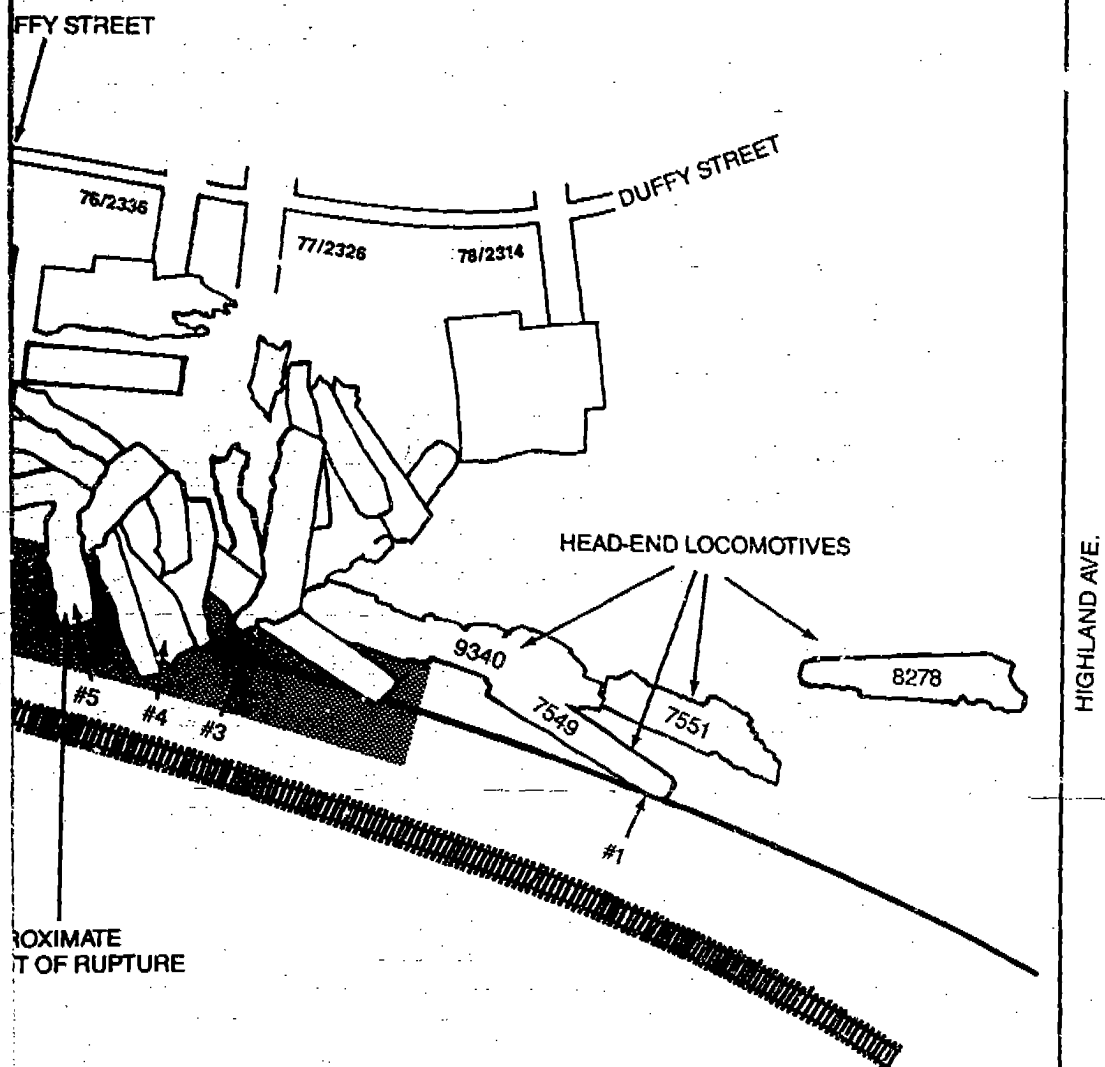
Figure 4. -- Wreckage distribution and location of

Calnev officials then decided to excavate in an area north of the breach where, according to Calnev's manager of operations, "...bulldozers had been repeatedly going off the end of the haul road" (figure 4, excavation # 2). According to the Arizona Pipe Line Company foreman, who performed the excavation, about 1 foot of pipe length was exposed from the 1 o'clock to 3 o'clock position looking north. When asked if any damage to the coating or pipe was noted, the foreman replied, "Couldn't really tell by a visual look, and we didn't bother exposing anymore due to our objective was to determine depth and alignment of the pipeline at that time." The depth of the pipe at this location was determined to be about 7 feet. With respect to the depth of the pipe, Calnev's manager of operations testified, "...it was sufficient to where I was no longer concerned about any damage from the bulldozer activity."

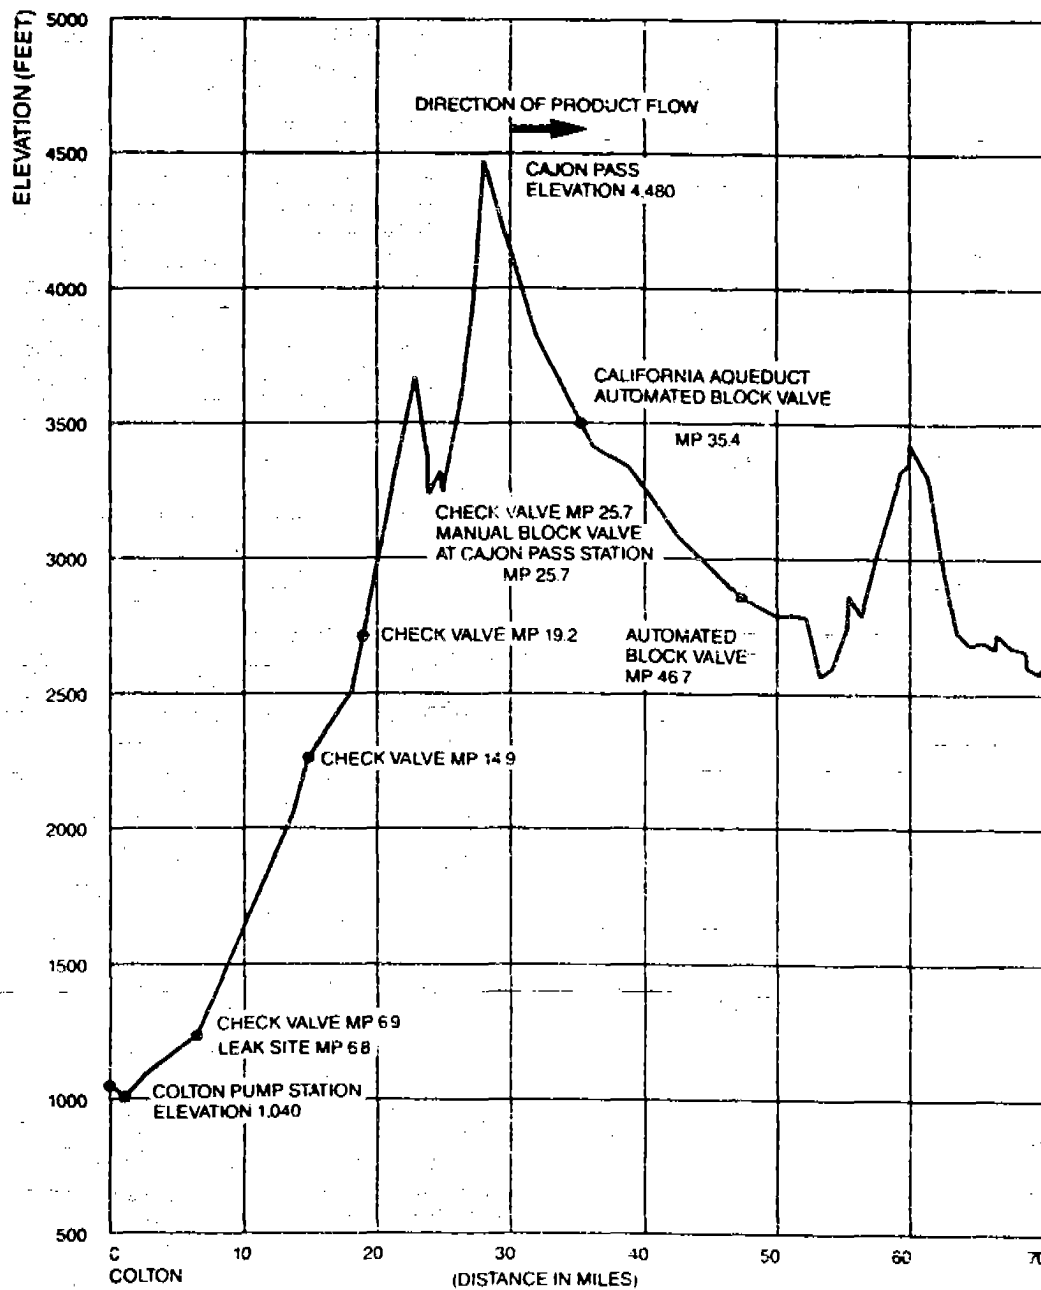
Figure 5.--Elevation of Calnev pipeline.

indicated that the pressure had been reduced by equal amounts, which indicated to Calnev personnel that the check valves still had not seated. The 200-psig reduction also indicated that the remaining pressure on the line was due to the weight of the liquid and, as the maintenance superintendent stated, "that additional efforts would be only minimally successful in reducing the pressure at the Highland Avenue location [derailment site]," because backflow sufficient to seat a 14-inch check valve clapper could not be induced by withdrawing product through a 1 1/4-inch opening. As a result, Calnev suspended activities to reduce further the pressure on the pipeline, which at 10:00 a.m. on May 12, was 800 psig at Colton, or about 50 percent of the maximum operating pressure established by Calnev. According to Calnev's manager of operations, Calnev did not at that time consider the possibility that the check valves were malfunctioning, but believed that the check valves did not close because of the inadequacy of the method used to induce backflow.

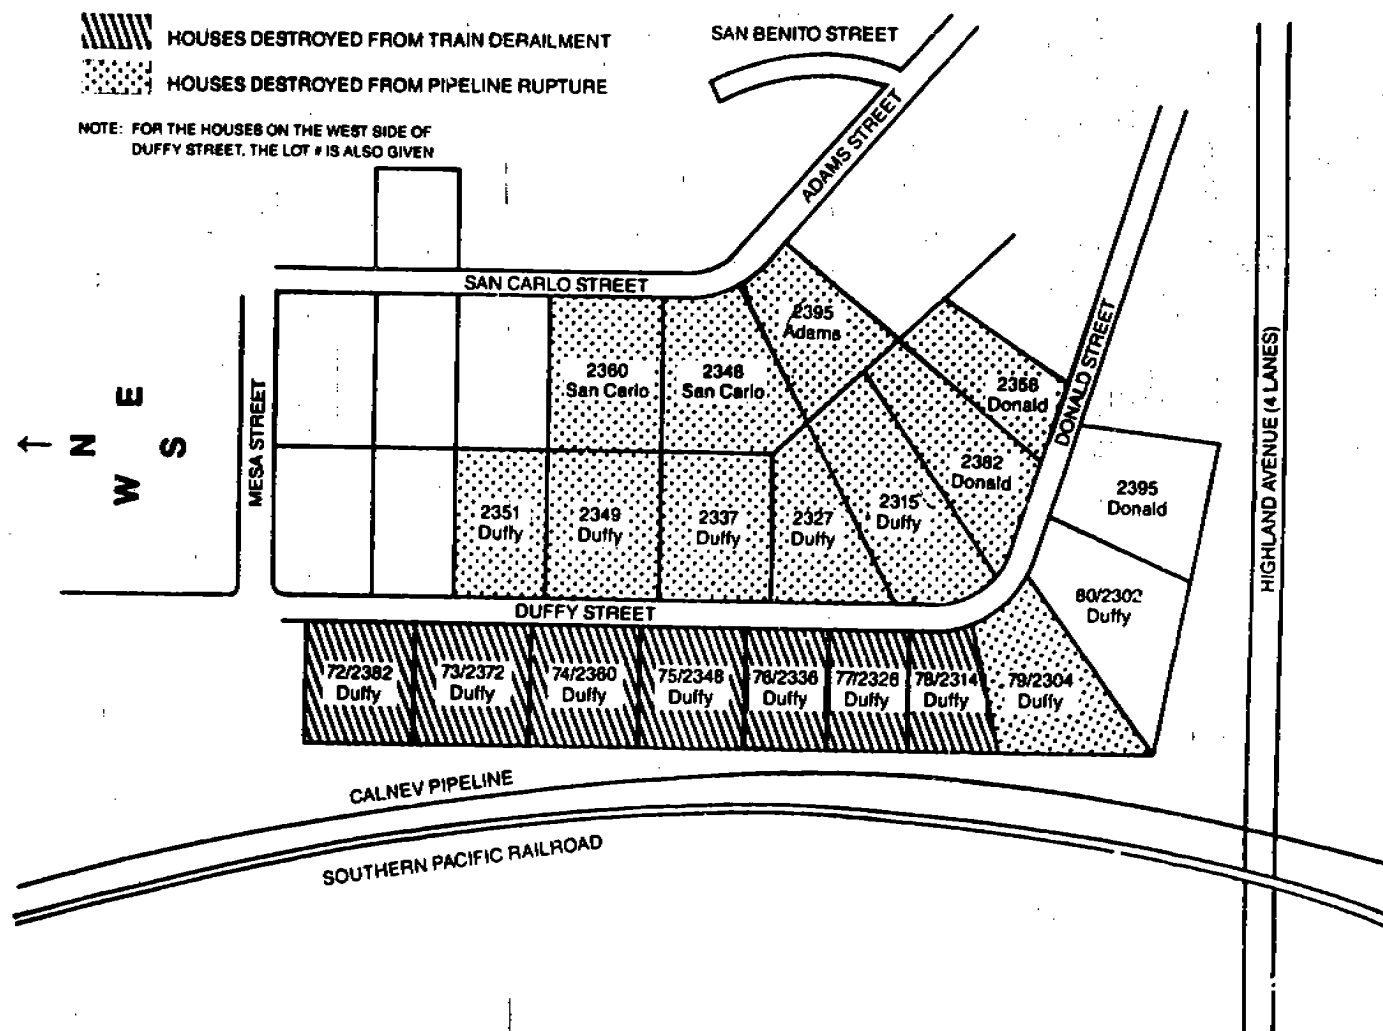
Figure 11.--Damages to residences.

Following the derailment, a building inspector from the City of San Bernardino Department of Building and Safety inspected the houses that incurred damages as a result of the derailment. The inspector's assessment of damages is listed in Appendix F. The inspector recommended that dwellings at 2314 Duffy Street through 2382 Duffy Street be demolished immediately (figure 11).

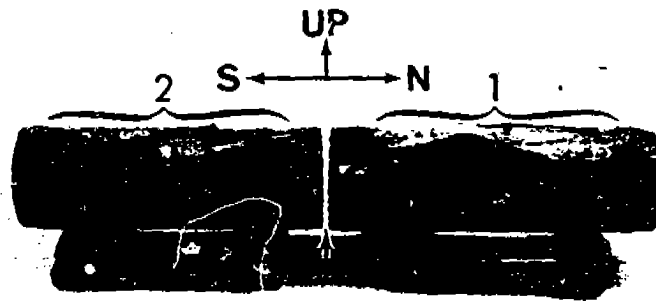
**Metallurgical Testing.**--Two 14-inch outside diameter (OD) pipe sections, one measuring 44 inches long and containing a rupture and one about 41 inches long, were taken to the Safety Board's materials laboratory in Washington, D.C., for examination. The two sections of pipe had been adjacent to each other before they were cut apart. As received in the Board's laboratory, the pipe contained directional arrows and a marking along the top of the section to indicate orientation of the pipe in the ground before removal. Arrows "N" and "S" denoted the north and south directions, respectively (figure 17). A longitudinal marking across the sections at the transverse cut signified the top of the pipe and the matching rotational positions of the two sections relative to each other. Yellow grid line markings had been made on the OD surface around the rupture area. Subsequent notes supplied by Failure Analysis Associates (the metallurgical consultants contracted by the SP to examine the pipe) indicated that these markings denoted positions where thickness measurements had been made on the pipe. Arrow "x" in figure 18 indicates a location where the wall thickness measured the thinnest at about 0.249 inch, which was confirmed by micrometer measurements in the Safety Board's laboratory. Wall thicknesses of 0.254 inch were also found in the origin area of the fracture. The wall thickness away from the fracture measured about 0.312 inches.

Figure 17.--Overall view of the pipe sections as submitted for examination.  
Approximately 1/24 magnification.

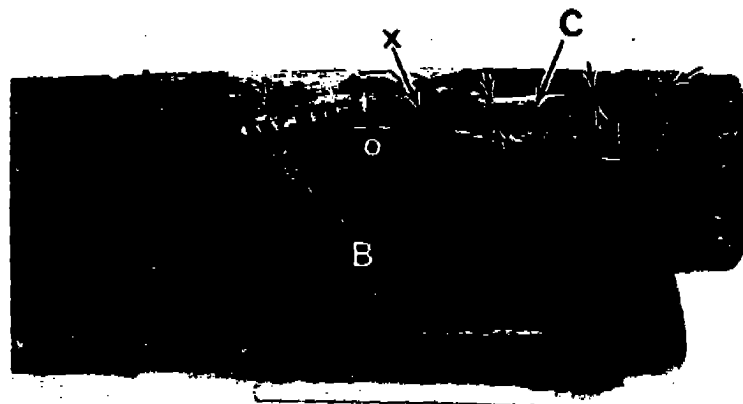
Visual examination of the fracture surface of the rupture disclosed no evidence of progressive cracking. All fracture features were typical of an overstress separation. A pie-shaped section containing the origin area of the rupture was excised from the pipe and further sectioned to a specimen size suitable for examination with the aid of a scanning electron microscope (SEM). SEM examination disclosed dimple rupture features throughout the fracture area that were typical of a ductile overstress separation. There was no evidence of crack arrest markings or oxidation areas that would indicate a progressive separation.

Figure 18.--Higher magnification view of northern pipe section containing  
the rupture (indicated by bracket 1, figure 17).

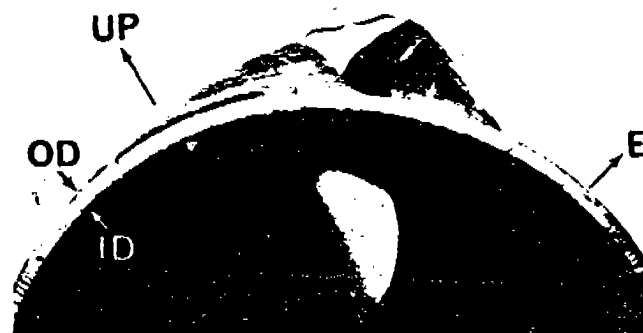
Figure 19.--Looking north on north section of pipe showing bulge in the pipe at the rupture. Bracket locates gap in rupture.
